①
NASA CR-135447

DEFINITION OF MUTUALLY OPTIMUM NDI
AND PROOF TEST CRITERIA FOR
2219 ALUMINUM PRESSURE VESSELS

VOLUME III APPLICATIONS TO RAIL DEFECT EVALUATION

MARTIN MARIETTA CORPORATION

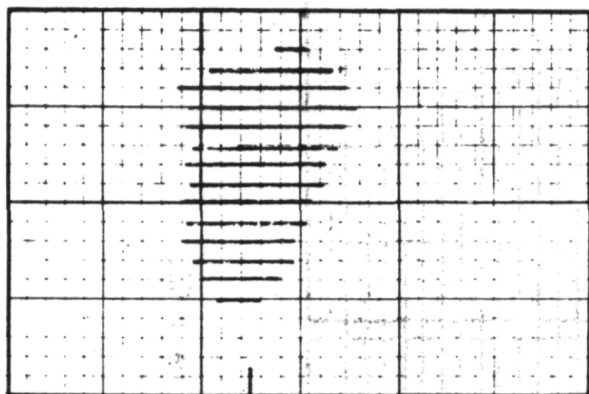
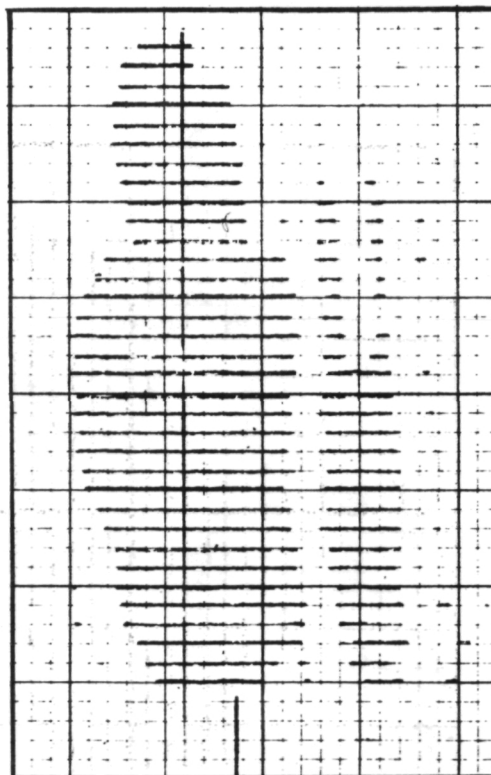
Figure 6. - Pulse-echo scans of top surface of rail 65.

Rail 65 was inspected in six directions, representing traverses from left to right and right to left (two directions) for each of the three surfaces (head and each side). Figure 6 shows the scans obtained by traversing the head in each direction. Note the significant difference in size and shape of the defect indications. Similarly, figures 7 and 8 show the scans for each side face. One trace was duplicated on the next day and was found to agree quite well with the previous result. Such scans had to be adjusted for the angle of transmission of the signal through the metal. By doing so and making a composite of the seven scans (six directions plus one repeat), the representation of the defect shown in figure 9 was obtained. Experience has shown that a better correlation with actual defect size was obtained by incorporating a correction for beam width. Figure 10 illustrates the reduction in size of the indicated defect by half- and full-beam-width correction and compares actual defect size and shape.
